EPSON Product Support Bulletin

| PSB #: | PSB.2007.04.001 | Authorization: | <i>[Signature]</i> |
| Subject: | Scanning Application Force Quits on Mac OS 10.4 | | |

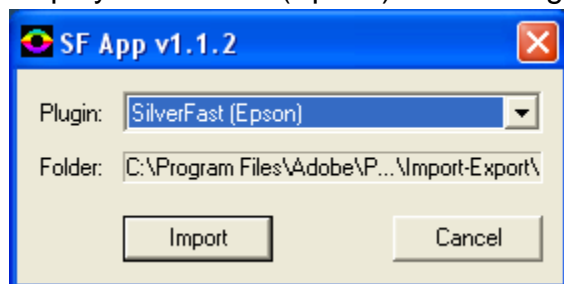
If you have installed Photoshop Elements 2.0 using the default location, the correct PlugIn folder that the SilverFast application should point to is: "C:\Program Files\Adobe\Photoshop Elements 2\Plug-Ins\Import-Export". If you do not use the default folder, then navigate to the folder you selected or created for Photoshop Elements 2 and choose the "Plug-Ins\Import-Export" folder. Once the correct PlugIn folder location is selected, the SilverFast Launcher window should display "SilverFast (Epson)" in the PlugIn window as shown in the example below.

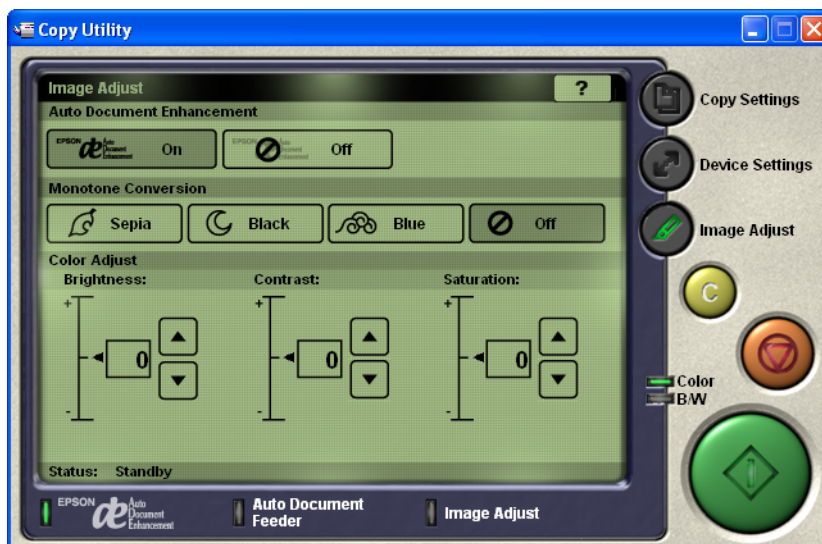
Click the ON button. You will now notice that this button is selected (highlighted in dark gray).

Now click on the large green Copy button, your image will be scanned and printed. The copy of your document should look very close to the original with no background colors added.

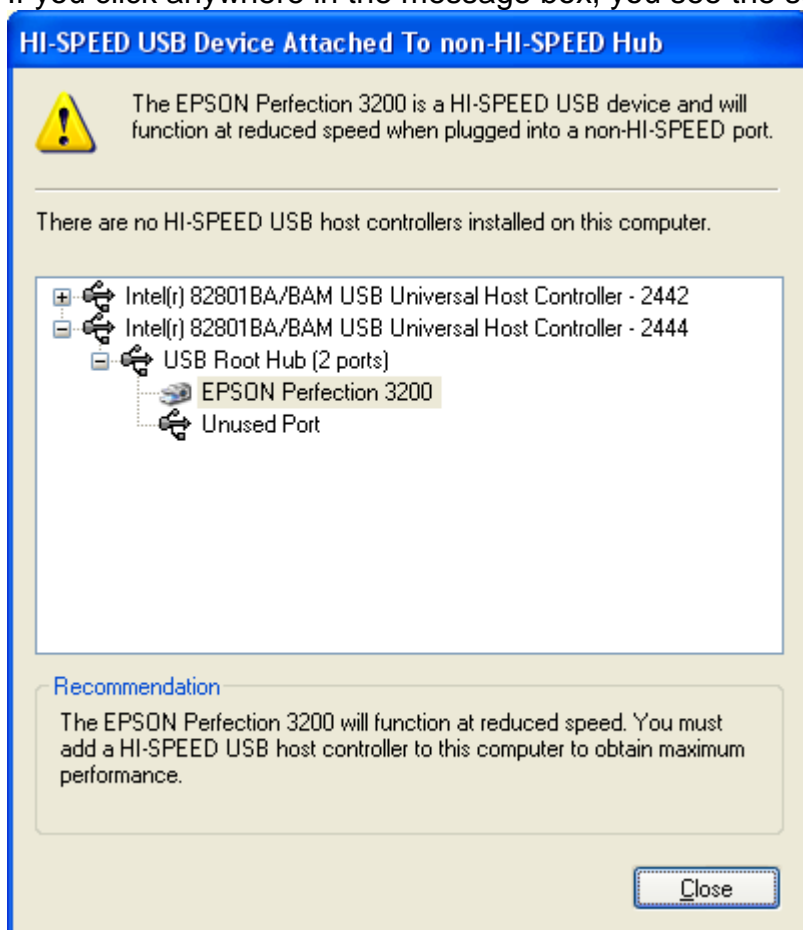
If you click anywhere in the message box, you see the screen below:

Click on the "Close" button to close the window.
